Introduction to PFAS and Firefighting Foam Release to the Farmington River

CEHA Annual Meeting
Portland, CT
November 1, 2019

Signature Flight AFFF Release – June 8, 2019

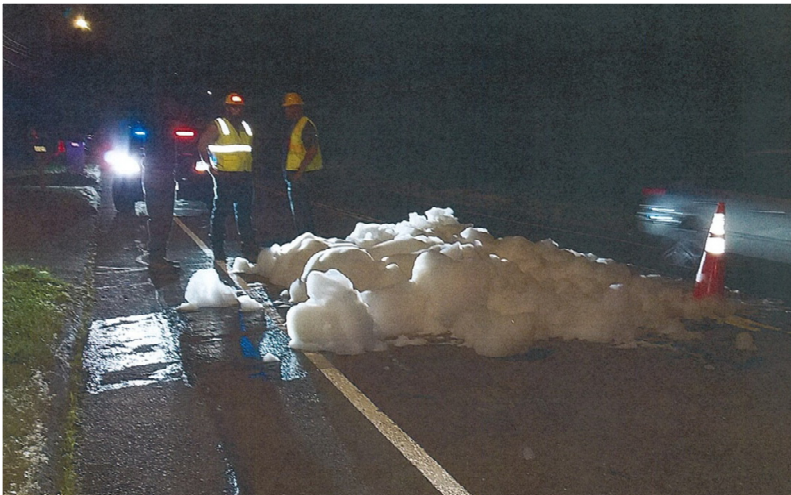
- Path of remaining foam solution:
 - Floor Drain → Oil-Water Separator → Sewer System → MDC Wastewater Treatment Plant → Farmington River
- MDC notified of release
- Approx. 7:30 pm, foam observed exiting vented sewer manhole on Rainbow Rd.
- Emergency Contractor called to remove foam from a manhole

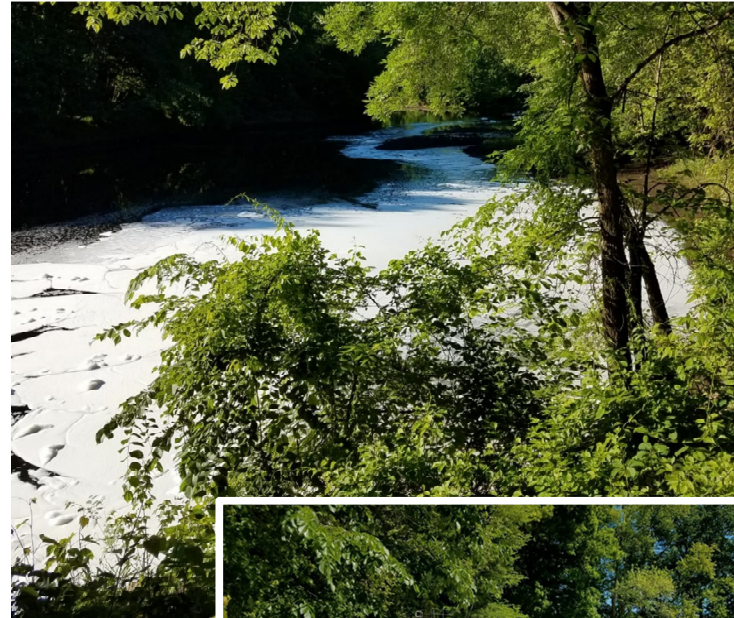
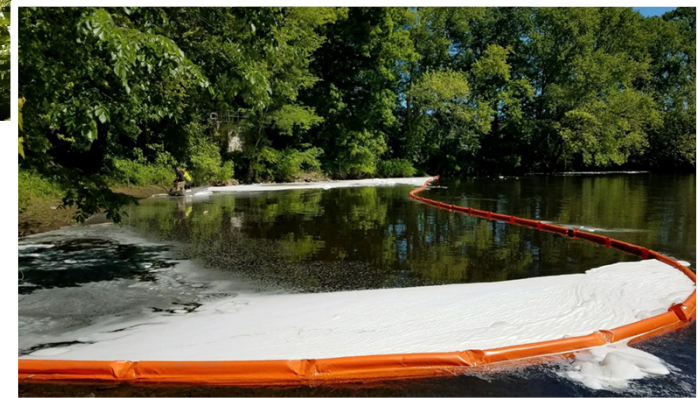
- Foam entered MDC Plant ~ 12 am and the Farmington River in the early morning (5:30-7:30 am) of June 9
- Booms deployed at MDC outfall to contain as much foam as possible
 - ~5,000 gallons of contained foam pumped from the river
- Surface water samples collected
- DPH advises no contact with foam/
do not eat fish

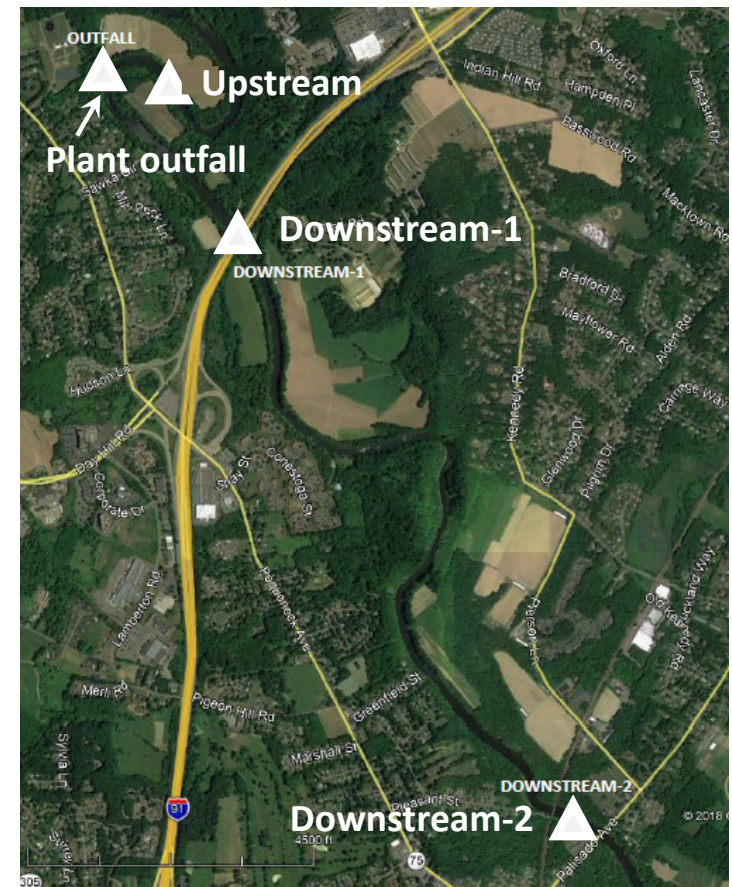
- 4 sampling events
 - June 9, 11 (Outfall only), and 21
 - July 10 (Upstream & Downstream-1 only)
- 4 locations
 - Upstream
 - Treatment plant outfall
 - Downstream-1 at I-91(0.6 mi.)
 - Downstream-2 at boat launch/Palisado Ave. (3 mi.)

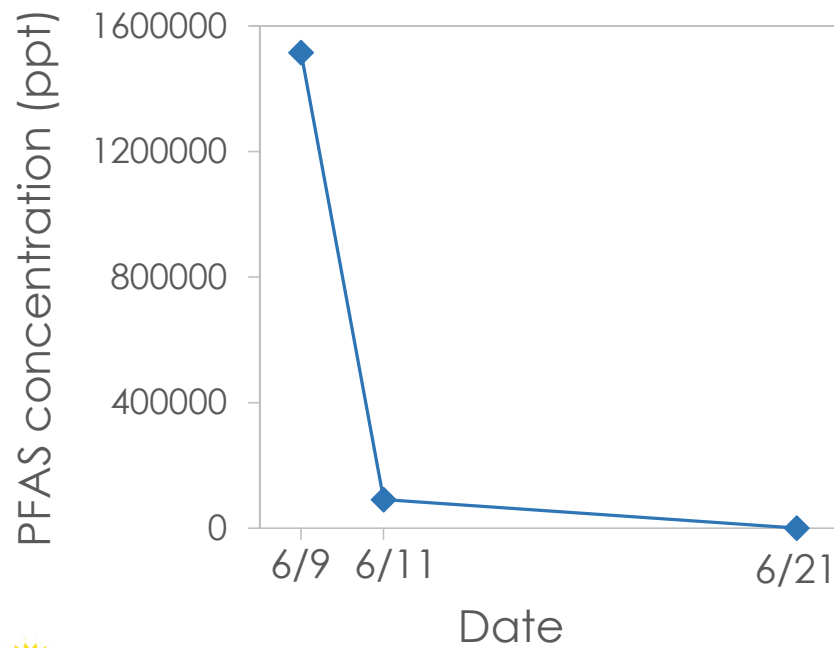
Concentration at Plant Outfall

- Total = sum of 18 individual PFAS
- Primary chemical is PFOS (1,300,000 ppt at outfall on 6/9, 86% of total PFAS)
- Total PFAS at the outfall decreased by more than 4,000 times over 12 days

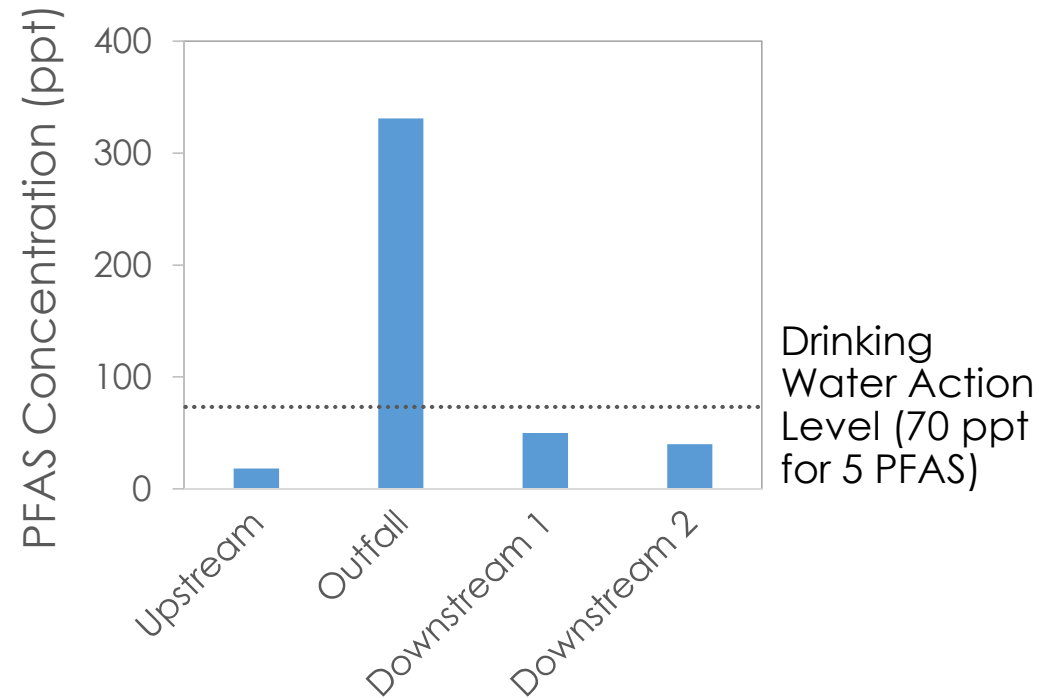
Concentrations (6/21)

Location	June 9	June 11	June 21
Upstream	38 ppt	--	18 ppt
Outfall	1,515,700 ppt	90,899 ppt	331 ppt
Downstream-1	13,300 ppt	--	50 ppt
Downstream-2	10,253 ppt	--	40 ppt

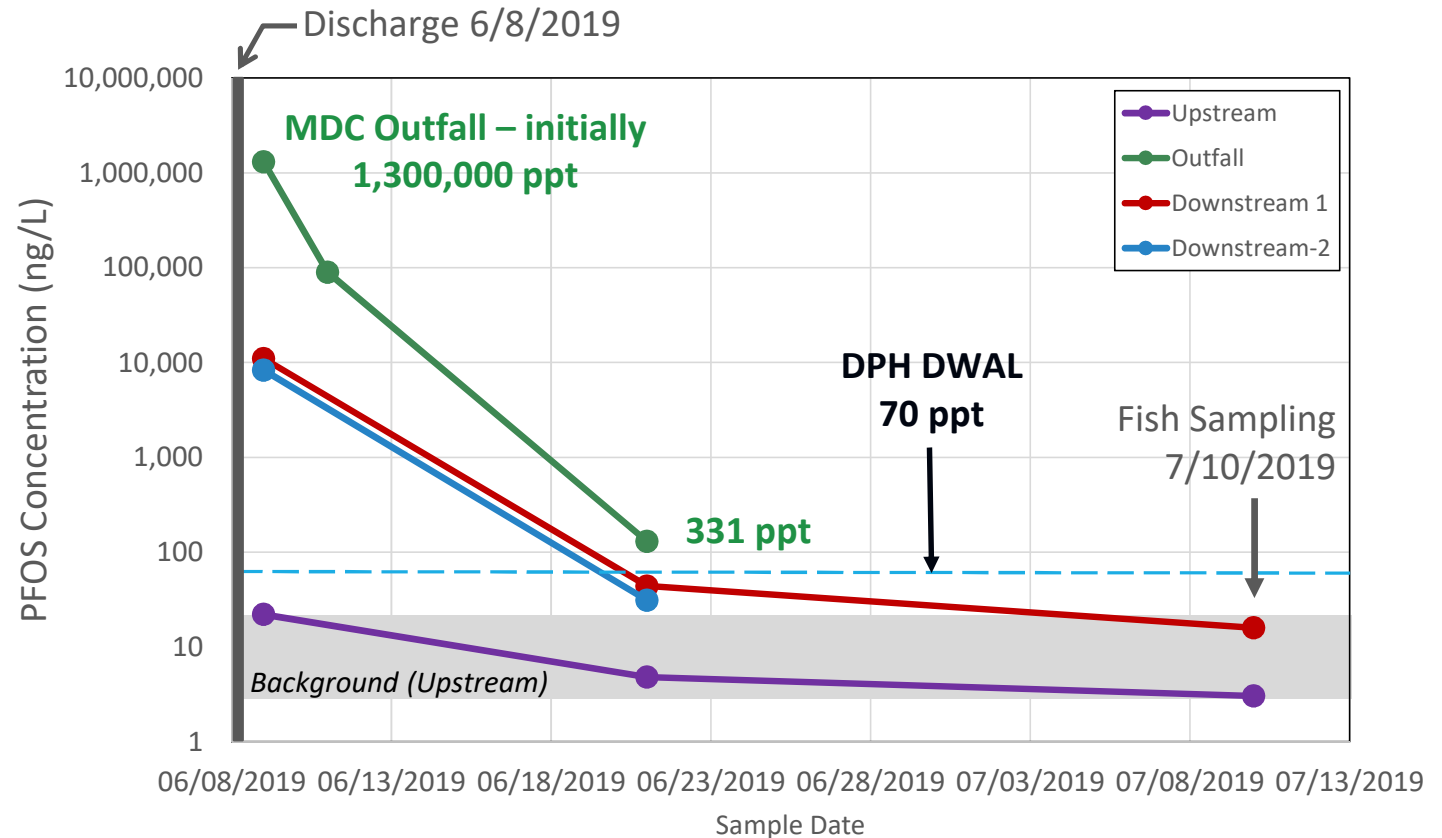
PFOS Concentrations in Surface Water

- PFOS concentration at MDC Outfall decreased 4 orders of magnitude by June 21.
- Downstream concentrations were within upstream range by July 10.

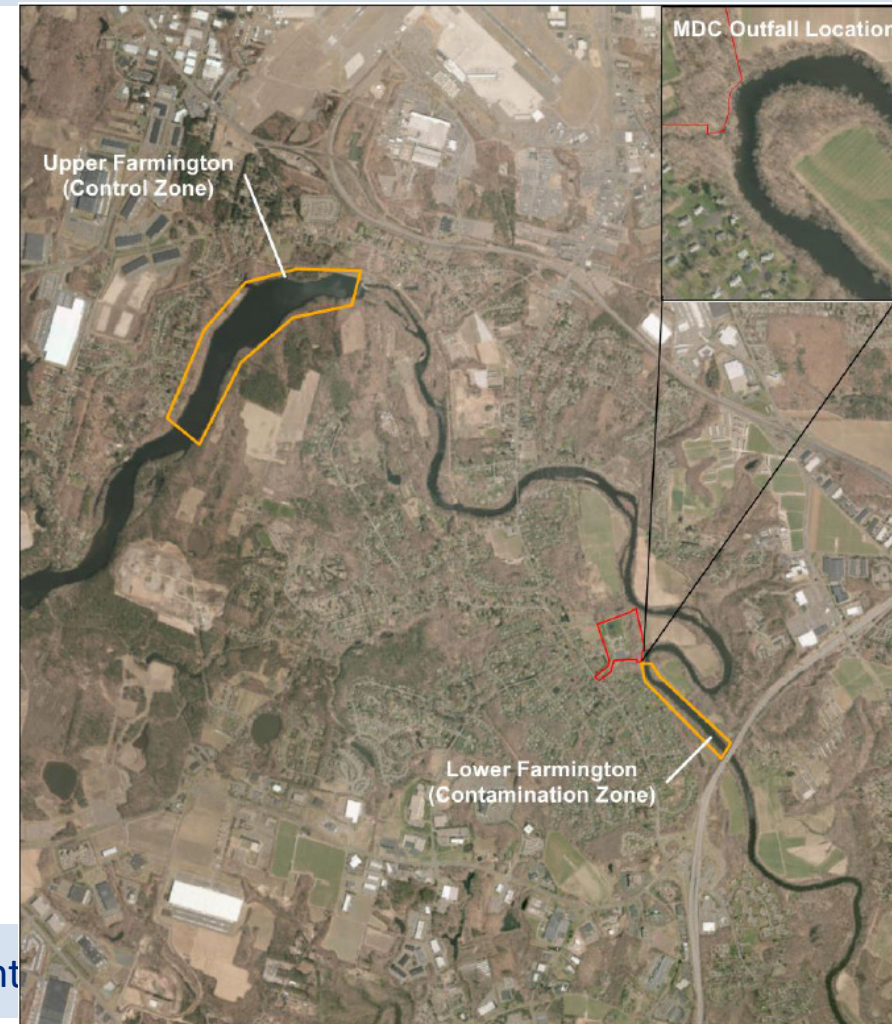
- 2 locations
 - Upper Farmington/Control Zone
 - Upstream of Rainbow Dam
 - Lower Farmington/Contamination Zone
 - Downstream of MDC outfall
- 2 fish species at each location
 - Predator (Yellow Perch)
 - Bottom-dweller (White Sucker)

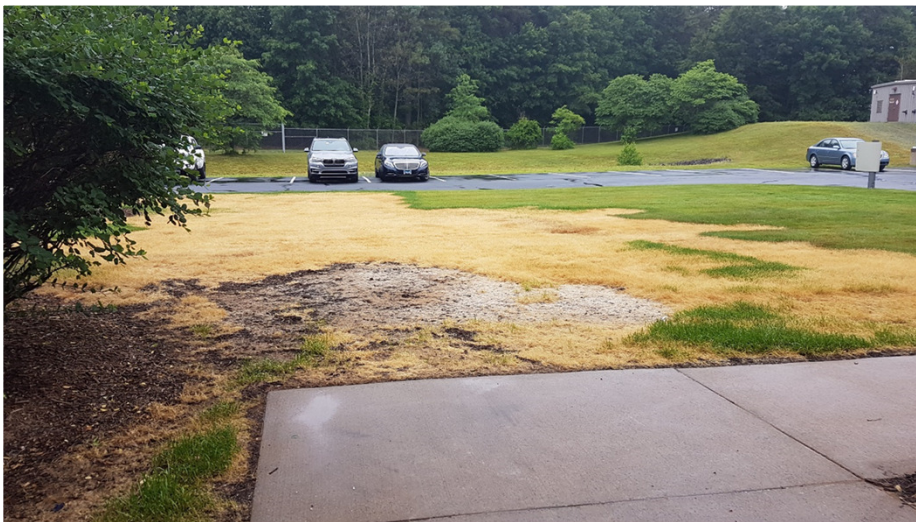
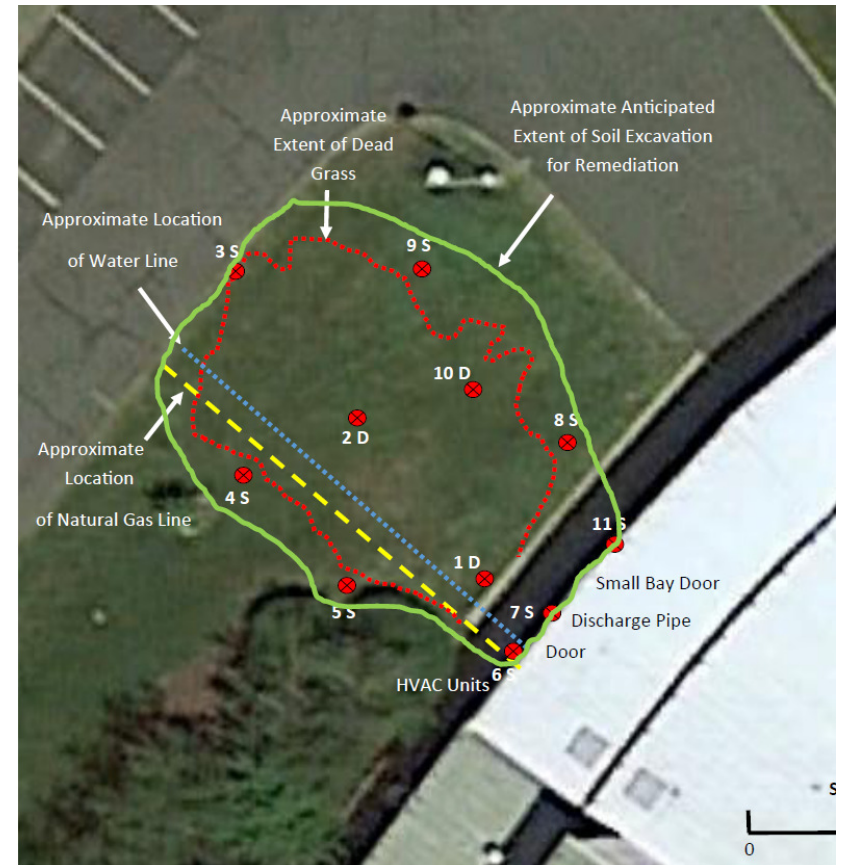
- Work scheduled to begin mid-November
- Excavate impacted soil and dispose via incineration
- Install monitoring wells

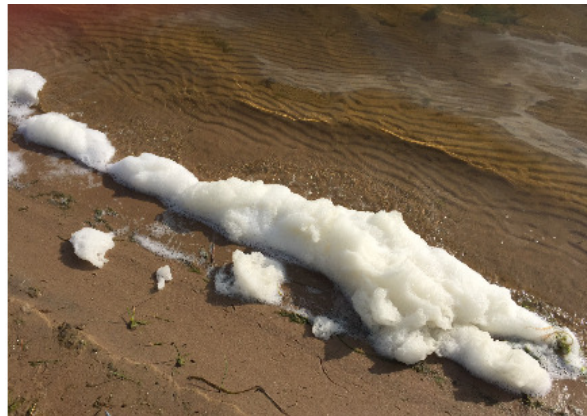
PFAS Foam

- Can be bright white
- Tends to pile up like shaving cream
- Usually lightweight
- May blow inland
- Can be sticky

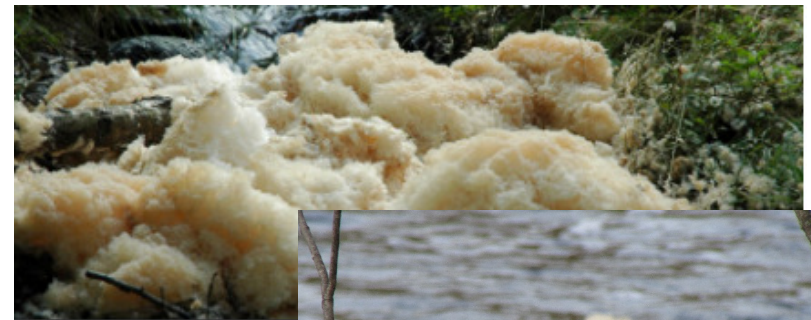
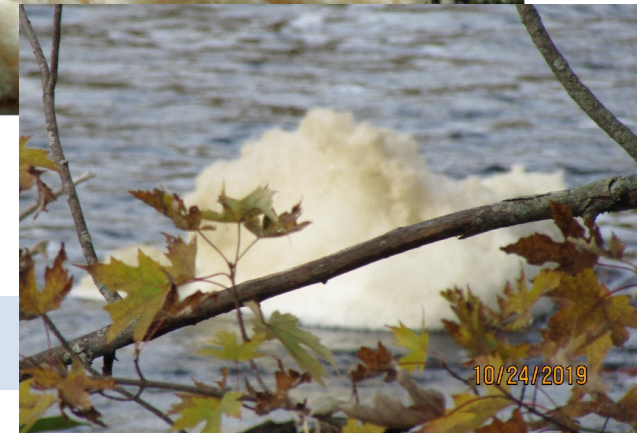
Naturally Occurring Foam

- Is off-white and/or brown
- Often accumulate in bays, eddies, or river blockages
- May have earthy or fishy aroma
